10. Discussion of the site at Broughton in comparison to a number of sites around the region.

10.1. Introduction

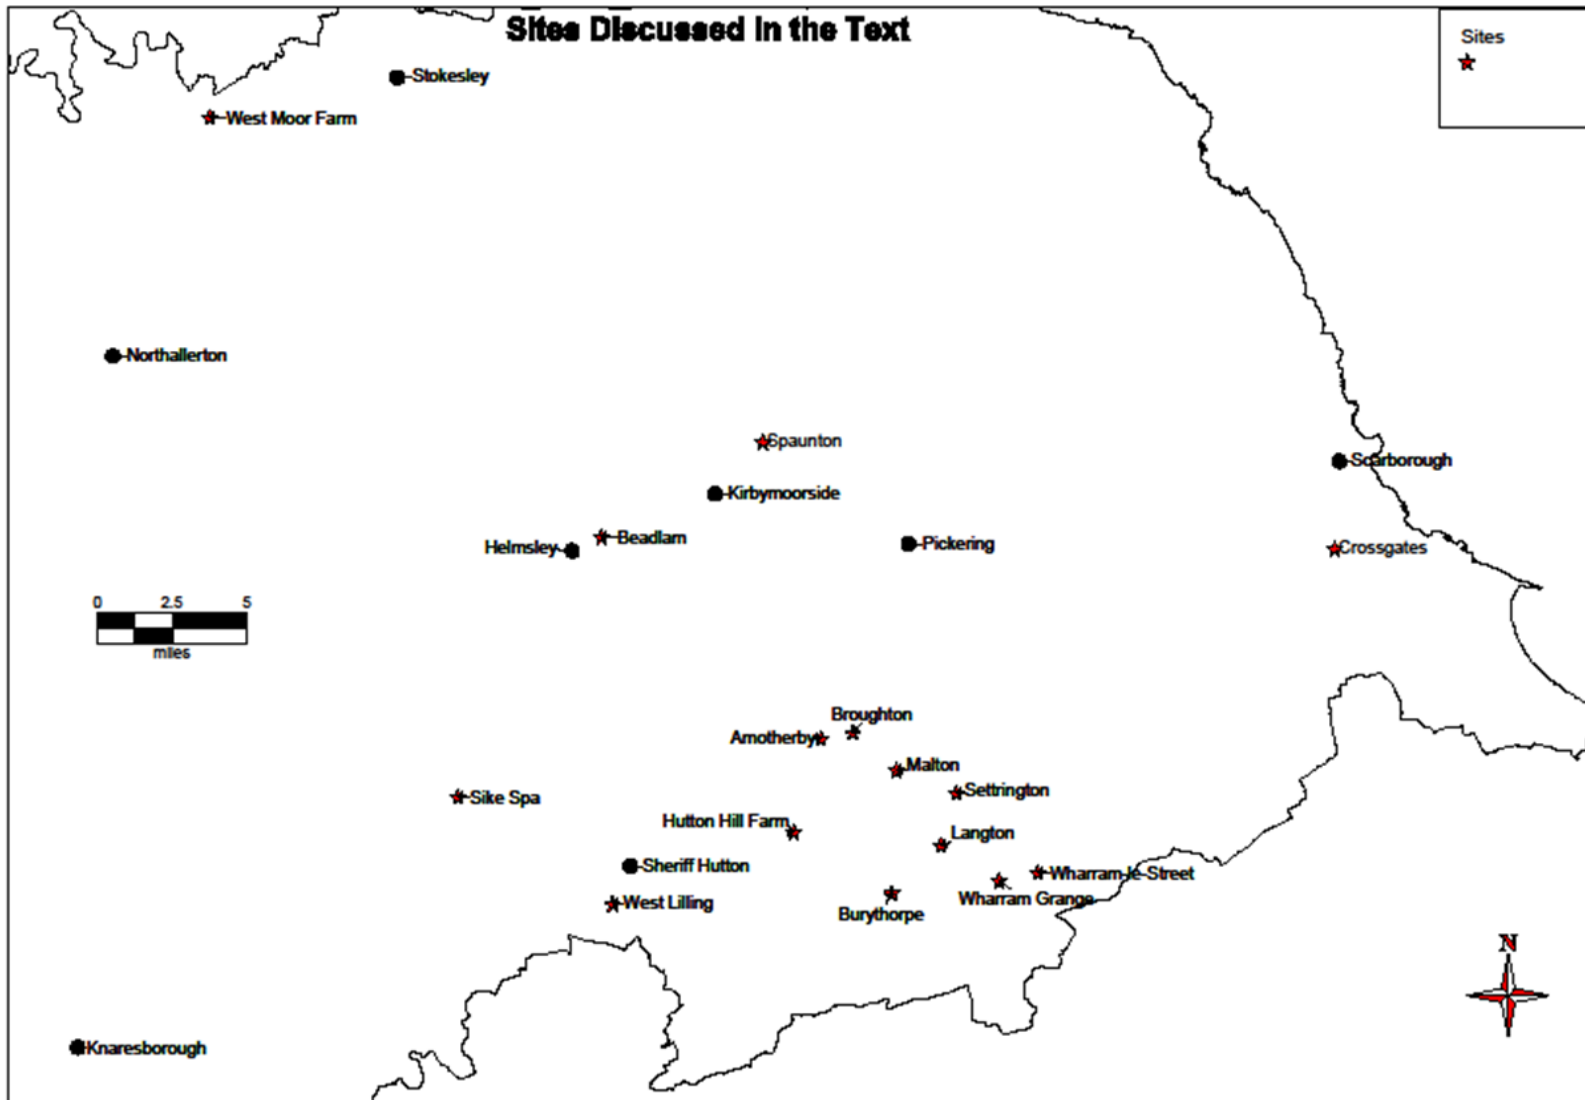
Figure 9 – Map of the sites discussed in the text

The sites identified for comparison to Broughton are (See fig 9):-

Farmsteads: Spaunton, Crossgates, Hutton Hill Farm, Burythorpe, Sike Spa and West Moor Farm

Villas: Beadlam, Langton, West Lilling, Wharram-le-Street and Wharram Grange.

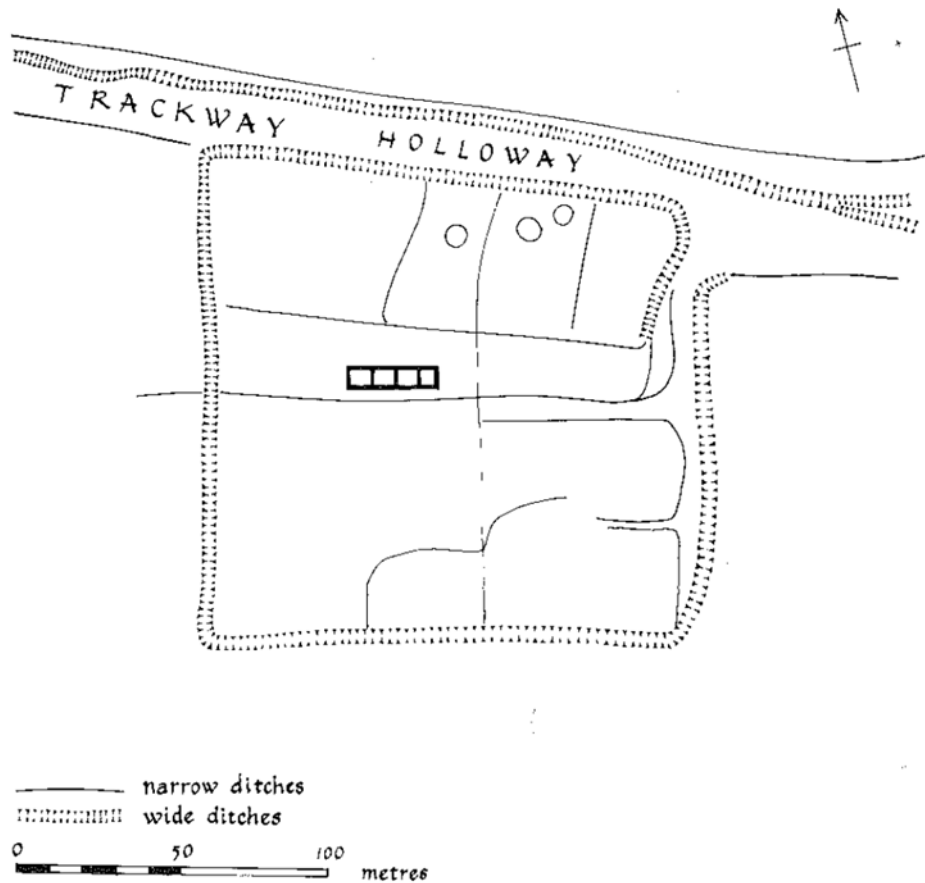
Figure 11 – Brough Hill, Settrington, after Ramm 1978

The closest site in form to Broughton as seen on the resistivity survey is at Brough Hill Settrington. Cropmarks have shown a four roomed rectangular building within a ditched enclosure. (Ramm:1978, p76). (See Fig 11) This site is two and a half kilometres north of Langton and is situated along a track which could be traced for seven kilometres and joins the trackway/holloway to Malton from North Grimston. The main building which measures 28 x 6 m and is divided into four rooms can be seen within a sub-divided enclosure, which also includes three round houses to the north.

This example has not been excavated so all we can see are the predominant features causing the variation in crops and vegetation in the field. However the form of the latest phase at Broughton, as can be seen on the resistivity survey appears to be in the same form as this structure. If the Broughton site is within an enclosure ditch or has any other associated structures of any kind, remains to be discovered. A more recent geophysical survey, to be reported on in the next interim report (forthcoming), suggests there may be an outer enclosure, but this remains to be tested by excavation.

As recorded earlier the Broughton wall foundations were mostly around 0.80m wide and between 0.08m-0.15m deep. The depth and the surviving lengths of the foundations are dependent on the rate of survival and on the amount of damage by plough or by robbing out, but the width is surprisingly similar on these sites with Broughton, except for Sike Spa where they were wider and probably able to support two stories. The dimensions of the overall structure at Broughton so far as they can be determined are 14.2 x 6.4, although the walls do not join in the south east corner and the rest of the structure is outside the excavated area, these dimensions appear to be similar in size to the above sites. However, measuring from the resistivity survey the structure may be as large as up to 30mx7.5m, although probably slightly smaller due to the spread of the high resistance areas. The crop mark at Settrington measures 28m x 6m and is of the same rectangular form as Broughton, seemingly divided into four rooms, See Figure 11 (Ramm:1978, p77).

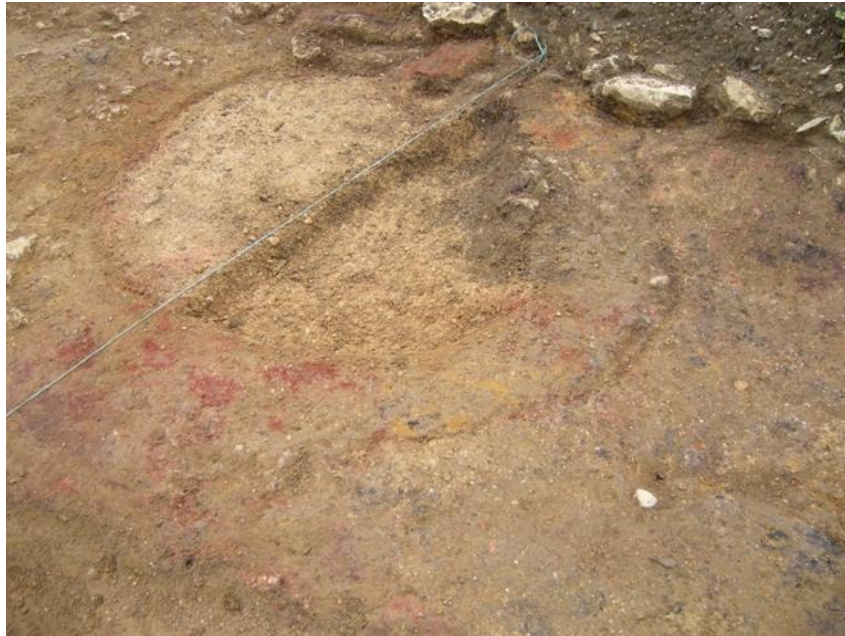
Plate 20 – The crushed limestone/mortar? fill (4076) of the “Lime Kiln” (4123) T4x1. See Figure 12 for scale

The fills of these kilns had much in common with the fills at Broughton. Wood ash or peat ash was identified at Spaunton, and wood ash at Langton. Reddened clay, burnt daub and large amounts of charcoal are common in all comparable sites with kilns:- Spaunton, Crossgates(III), Hutton Hall Farm, Burythorpe, Sike Spa, West Moor Farm, Langton and West Lilling. Sometimes other material was specifically mentioned, such as a burnt red lining at Spaunton and Crossgates III, Grey plastic clay and heat affected sand at Hutton Hill Farm and what appeared to be a white mortar in a flue at Spaunton, which may be similar to the limestone grit found in the first kiln at Broughton. (See Plate 20)

At Broughton the hearths/kilns differ in size and shape but all except one share similar fills. The first kiln to be found in T4 x1(4123) has been considered to be a probable lime kiln because its fill consisted of compacted limestone grit. (See Fig 12,13 & Plate 2). This kiln had the least evidence of burning, and was the only one to have a large limestone flag at its base, although this stone had no signs of burning. Three others were found in T4X2. One of these kilns had no flue and appears to be a clamp kiln, (4358) (See Fig 14,15, Plate 4) while another was in the shape of a figure of 8, (4310/4312) (See Fig 16,17, Plate 7), the last one showed several phases in its construction and had evidence of metalworking.(4366,4371,4372) The flue of the lime kiln cut through these contexts.(4361) (See Fig 18,19,20, Plate 6). The three kilns in T4x2 and further kiln/hearths discovered in T6 to date all share reddened linings, not thought to be deliberately lined with a different material but the cut of the features having been affected by intense heat in situ. The fills of these kilns contain a mixture of burnt deposits of ash, burnt stone and daub with a small number of burnt bone fragments and deposits of charcoal

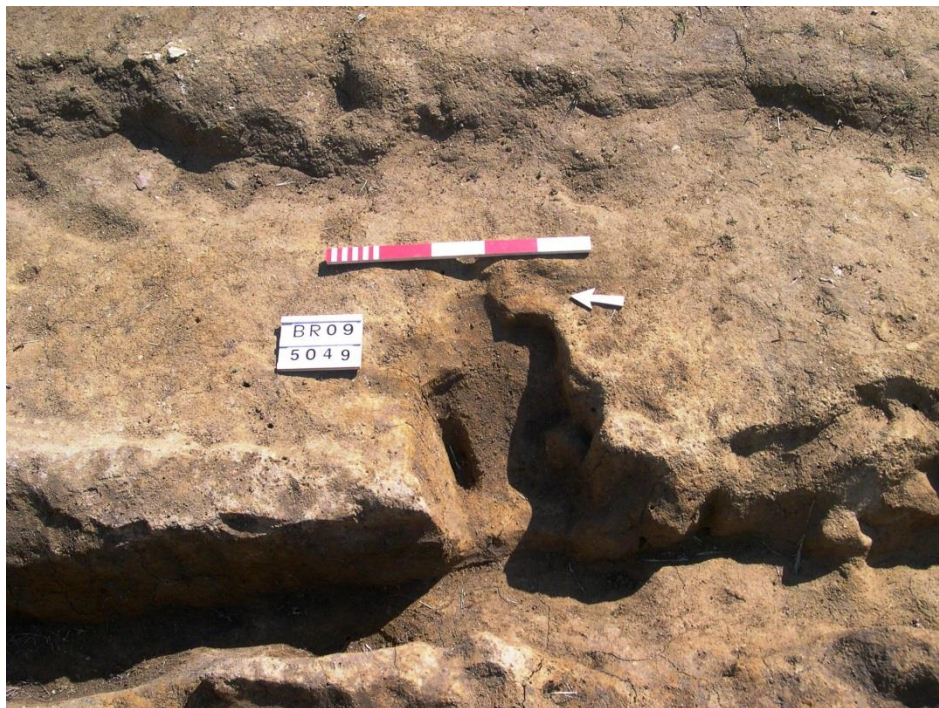
Plate 21- Post Hole (5049) adjacent to a beam slot and beneath the cut of wall foundation (5009)

Firstly there are some features that have been found directly beneath the wall foundations. Under the northern wall in T4 x1 (4107), a deep post hole with packing stones was discovered (4111). In T4x2 a possible post hole (4248) was found beneath the wall foundation (4264) (See Fig 4.) In T5 & 5X1 a possible beam slot (5045) was cut by the wall foundation (5009), and post hole (5049) was beneath it. (See Fig 5, Fig 21 & Plate 21) Beneath the short southern wall section in T6 (6085), a slot running across the width of the foundation and into the trench edge was recorded (6098), this was also stone filled but much narrower (0.40m) than the wall foundation (0.80m). (See Plate22-23)

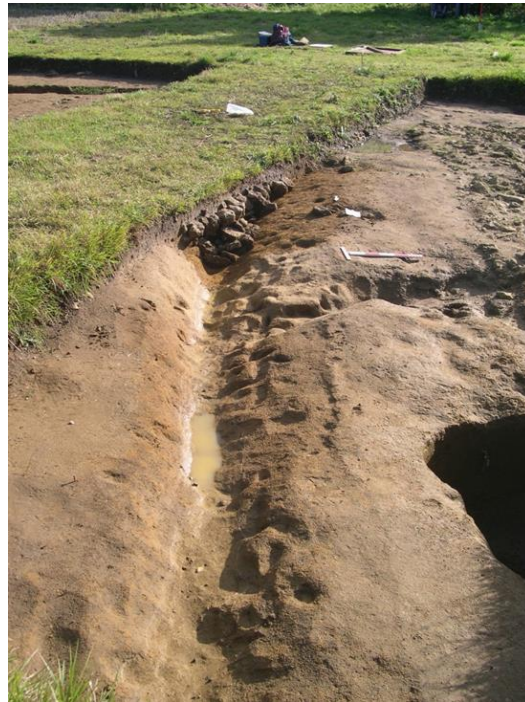
Plate 24 – Possible drainage gully (5004) See Fig 24 for scale and detail, also Plate 40

least were still in use at the same time, and backfilled with this material. A gully (5004) was interpreted as a possible drainage gully associated with the structure represented by the wall foundation (5009). This may be a possible drip gully for drainage from around the structure leading into a gully in T3 (3023) that runs into the deep ditch (3015). (See Fig 24,25,plate 24). This is an interesting feature not identified amongst any of the comparable sites.

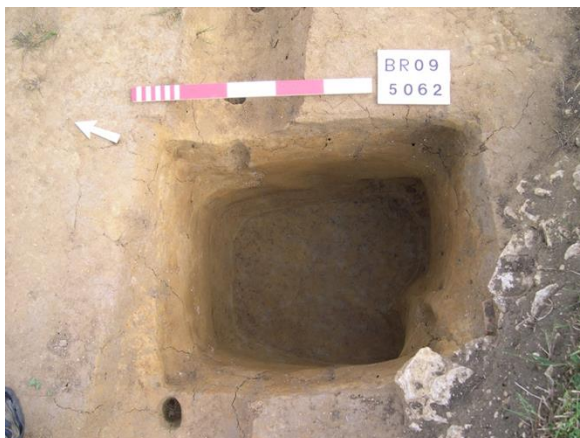
Plate 25 – Square Post Hole (5062) depth = 0.77m

Three square post holes (5050), (5062) and (5065) appear to be similar features to the two found in T4 X1 & 2 and with two others recently found in T6 it is a possibility that they may be associated with each other in the same phase. (See Plates 25-26) (5062) is cut by a possible beam slot or post in trench fence/structure (5058) showing it to be one of the earliest features, this is reinforced by the spot date of pottery to the Late Iron Age/ Roman. (See Fig 26, Fig 5 & Plate 17). This seems to coincide with the relative phasing of the other square post holes which are stratigraphically beneath the stony features and possibly associated with the apsidal ditch.

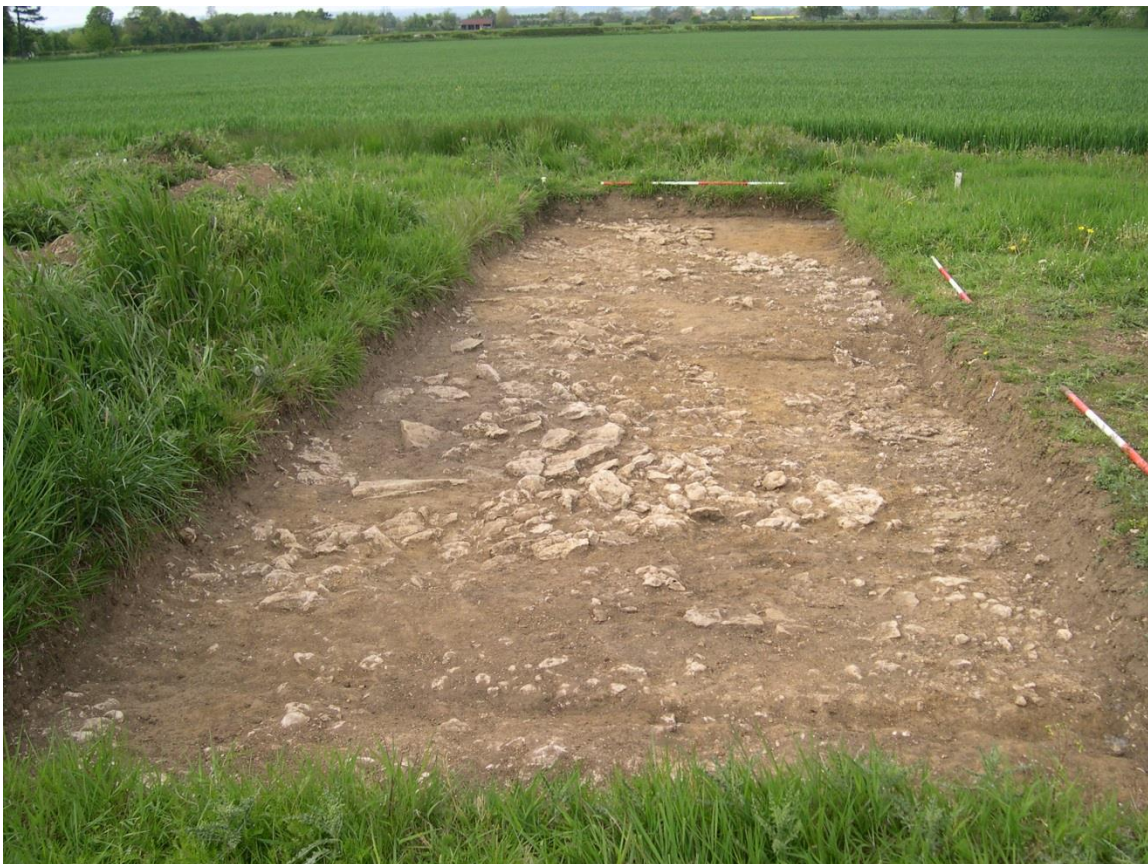
Plate 27 – Rubble spreads in T5

The rubble spread in these two trenches gave the impression of being a rough surface that had been laid and compacted, but it is also possible that after collapse or demolition the material had been spread and compacted over time by agricultural use of the field. The spread was made up of stones of varying size and shape packed together with no apparent structure. Although within the rubble spread other features were found; for example, context 4069 was within this layer in T4x1, immediately under the top layer of small pieces of limestone rubble. This consisted of a flat topped stone surrounded by smaller flat stones set slanted on end in a hollow, and was interpreted as a possible post pad. This contained pottery dated to 140-200 AD. Other similar features were noted but could not be definitely determined as real features. Some areas of burnt stone were also identified amongst the spread. The rubble spread came to an abrupt stop diagonally across trench T4x1 in a NNW-SSE direction and across T4x2 in an E-W direction. To the eastern side of T4x2 the spread continued into the trench edge, into what is now T6, and to the south of both trenches the spread came to a more gradual end. The phenomenon of the straight edges remains although with the lack of structural evidence for internal divisions between rooms for example, beneath or adjacent, it is perhaps likely to have been a demolition/collapse layer of the external walls, subsequently spread by the plough. The rubble spread also occurred in T5 & 5x1 occupying the area immediately surrounding and over the wall foundations, and was interpreted in the same way. See Plates showing rubble spreads in T4x1, x2 & 5 (Plates 15,16 & 27)

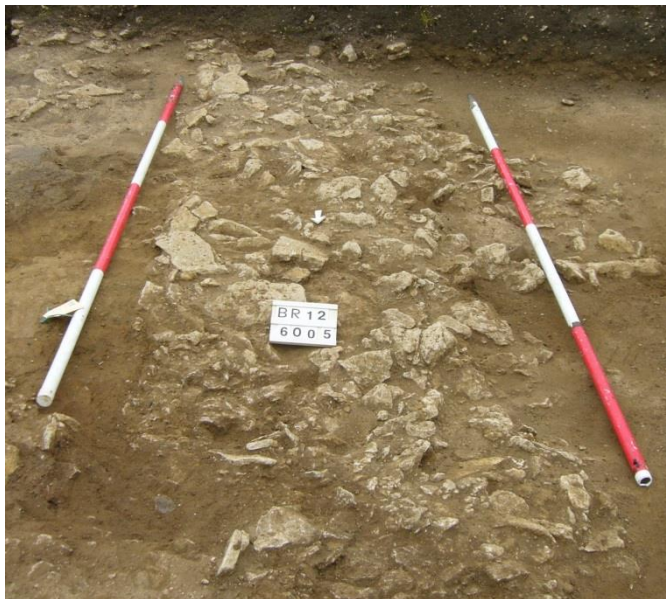
Plate 28 – (6005) Wall foundation in T6

The section of foundation in T5 & 5x1 (5009) measure 6.4mlong, 0.8-1.0m wide and 0.20 deep, in a NW- SE direction, then turned NE-SW for another 3 m, where it ran into the edge of the southern end of the trench towards what is now T6. Another short section which is less clearly seen on the resistivity survey was identified in the southern end of T6 measuring 2.2mx 0.8m wide and 0.8m deep, on the same NE-SW alignment, which then joined another short length of wall which ran northwards from the southern edge of the trench for 2.40m 0.80m wide. No join between the wall foundations in T5 and T6 was discovered during excavation. The area where they may have joined had been disturbed so it is unknown if these walls joined originally. (See Plates 12,13,14,28,29,30,31)

In all cases the remains of the wall foundations consisted of limestone rubble, with some larger slabs present in places, and were substantial enough to support at least low stone walls, but probably not designed to bear much more weight than that. These would have provided enough demolition material represented by the rubble spreads found on site. As yet these foundations cannot be demonstrated to have been joined together to form a whole structure and their form can only be projected, as seen on the resistivity survey.
